West Virginia Office of Miners' Health, Safety and Training

Report of Fatality
Underground Accident
Pinned By Machinery

G.M.S. Mine Repair & Maintenance
Permit Number C00001932

Berwind Deep Mine
Permit No. U00300816

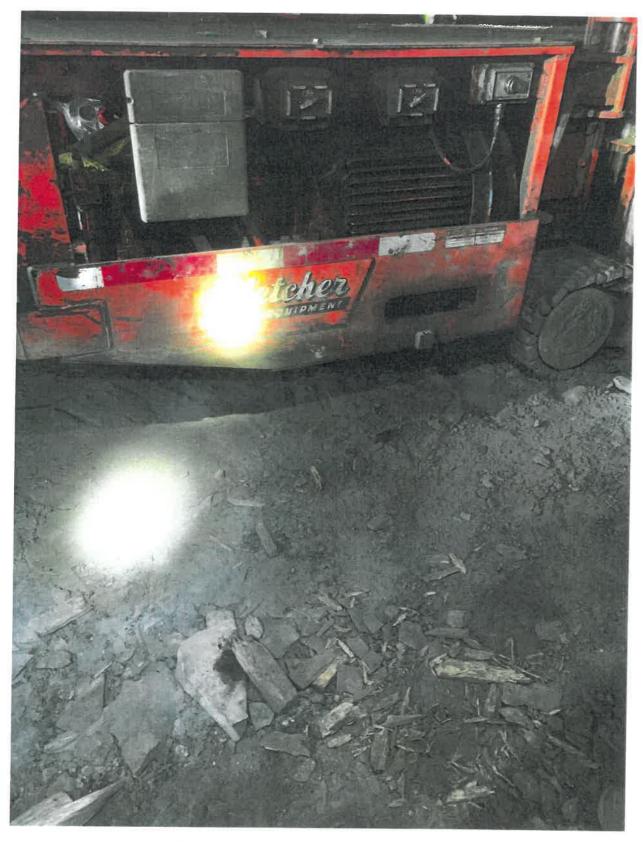
Right, rear of the Fletcher Single Boom Face Drill. Location of the victim's body.

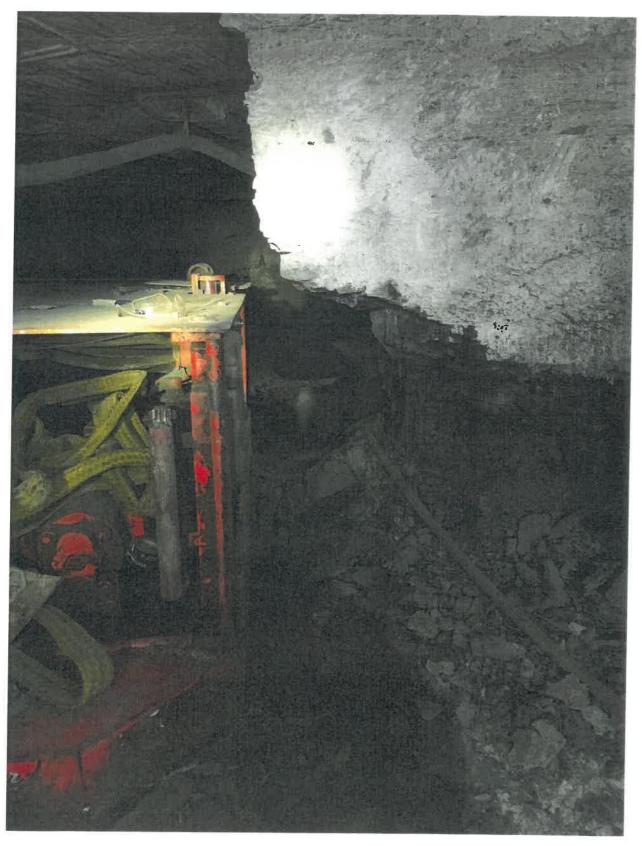
Fletcher Single Boom Face Drill repositioned to the accident scene.

During the investigation of a fatal accident involving the Fletcher Single Boom Face Drill, this machine was found to have not been maintained in a safe operating condition, in that the tram lever for the right-side track was not properly adjusted, causing the right-side track of the machine to move forward when in the center locked position. The above violation is a health and safety rule of a serious nature and involved a fatality.
